POLYFLAKE® LLC

**MARINE
CORROSION
ENGINEERING**

Cruise Ships Swimming Pools

**Revamping & Improvement
Turn-key solutions**

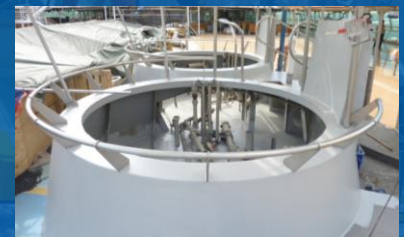
Jacuzzi's Basement Coating

- POLYFLAKE® coating technology provides the best corrosion barrier to the basements and deck under the Jacuzzi pools.

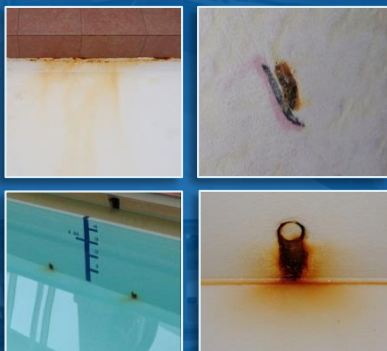
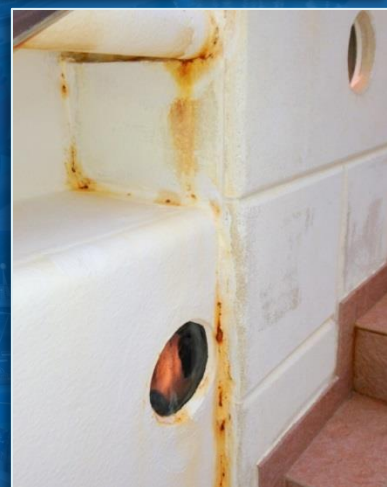
Common defects and pitfalls of standard treatments

- Any discontinuity in the pool base shape is a potential starting point of corrosion.
- Accessories, lighting fixtures and nozzles are the weakest points in the corrosion chain as mechanical shocks on the treated surface.

Traditional treatments shows immediate evidences of local cracks and coat deteriorations.

- All coat degradation areas and mechanical shocks are immediately marking the pool surface with unaesthetic shades and rust spots.
- Treatment patching is almost impossible and need sensible downtime with discomfort for the passenger in one of the most loved and frequented ship areas.
- The patches do not solve the problem of the water penetration; behind the coat inevitably starts to corrode the carbon steel structure with rapid reappearance of rust spots and shades and possible local damages to the ship superstructure.
- POLYFLAKE® treatments resolve definitely all those problems; higher resistance and easy repairable just in case.
